## **Inspection Advisory**

### **Dyna-Lock<sup>®</sup> Self-Retracting Lanyard – 20ft. Models**

August 6, 2008

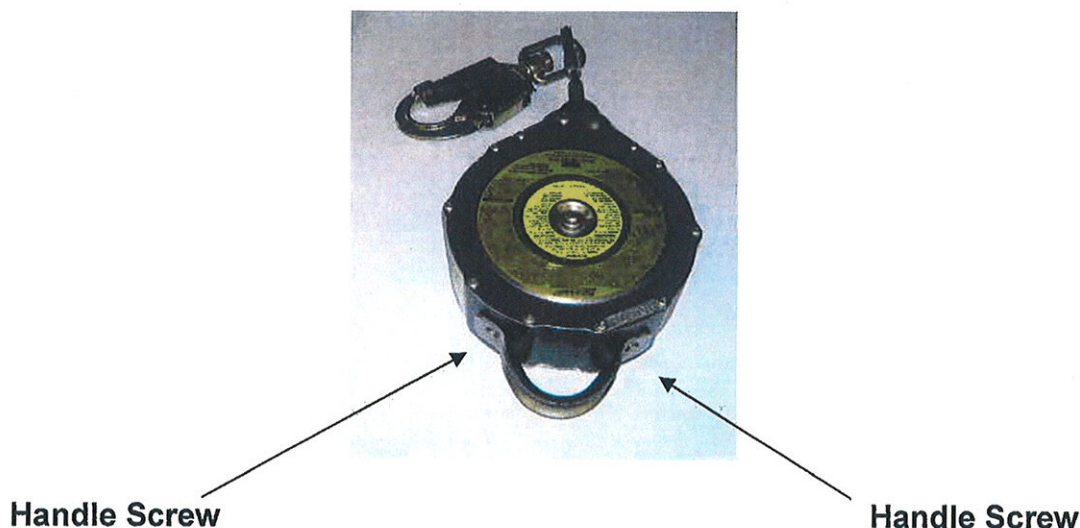
MSA recently received a report that the attachment handle on a 20 ft. Dyna-Lock Self-Retracting Lanyard (SRL) became loose and separated from the unit. Although the user was not injured, our inspection of the unit revealed that the ends of the two screws securing the handle were not swaged (flattened) as intended by our housing/handle supplier. The swaging process prevents the screws, which are installed from inside the housing, from unthreading. If a handle screw unthreads due to vibration or other means, the handle could detach from the housing and cause the SRL to separate from the anchorage resulting in loss of fall protection.

The photo below identifies by the arrows the location of the two handle screws to be inspected:

**As a result of this finding, MSA requests that users receiving this Inspection Advisory immediately inspect the 20 ft. Dyna-Lock SRLs in their possession to determine if the screws securing the handle are swaged. Any units with unswaged screws (one or both) must be removed from service and returned to MSA for repair. The repair and the shipping are free of charge. Units not exhibiting this condition may remain in use.**

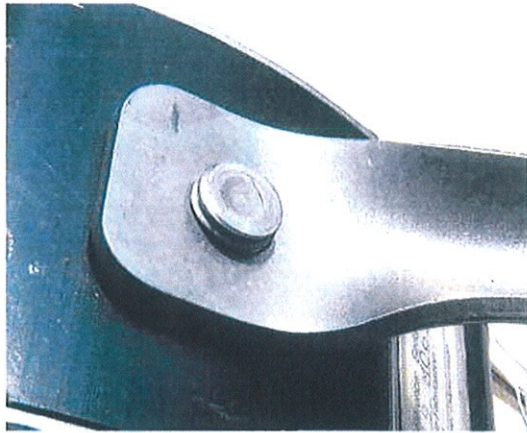
When inspecting 20ft. Dyna-Lock handle screws, compare them with the photos below. These photos illustrate the ends of a swaged (flattened) screw and an unswaged screw. Note that the swaged screw appears flattened; whereas, the unswaged screw has a cup shape appearance with a raised edge:

**Good – Swaged (flattened) Screw**

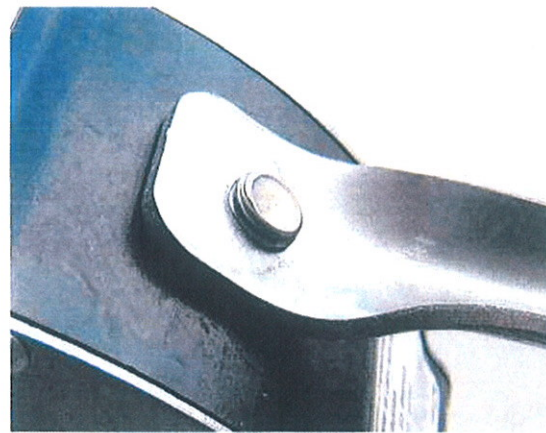
**Bad – Unswaged (cup shaped) Screw**

Upon inspection, if any units are found to have unswaged screws (one or both), immediately remove the unit from service. Complete the attached shipping form and return the unit and the shipping form to MSA at the address provided below:
